CASE STUDY

WHEATON – GRADED CATCHMENT AND WATER MANAGEMENT

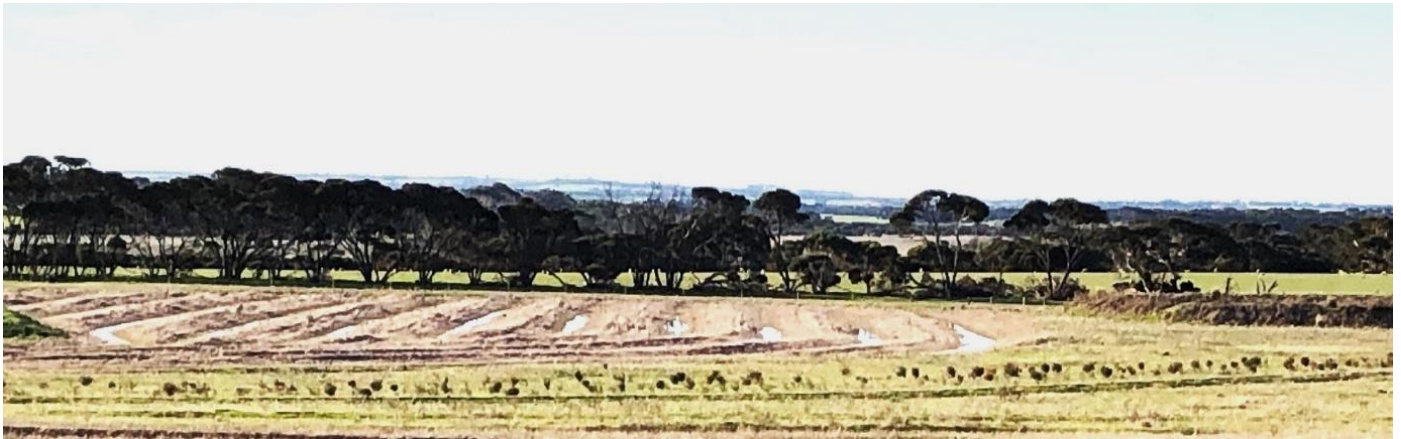
Graded catchment showing water in the drainage lines.

Graded catchments are designed to reduce rainfall soaking into the soil by promoting rapid run-off without causing erosion. By removing the topsoil and compacting the clay subsoil, the rain can more easily runoff into the dam. Work on KI has shown that graded catchments can increase runoff by over 50% compared to 10 -15% for pastured areas.

- 3. Construction** – the site was surveyed to enable a design of interconnected drains and graded catchments to fill three dams. Three dams were constructed as the underlying saline ground water did not allow for a single (deeper) large dam to be built. Drainage lines were designed with a <1% fall. The topsoil was then stripped off and stockpiled by the existing dams (giving Derek the option to on-sell the soil if he chooses), the runs were then cut down to the clay layer and the surface compacted.
